## Feasibility and Performance of Full-Scale In-situ Remediation of TCE by ERD in Clay Tills

## Feasibility and Performance of Full-Scale In-situ Remediation of TCE by ERD in Clay Tills.

**ABSTRACT:** The feasibility and performance of full-scale applications of ERD in clay tills were investigated in a research project including 2 sites in Denmark, which have been undergoing remediation since 2006. At both sites organic substrates and bioaugmentation cultures have been injected in TCE-contaminated clay till. An integrated investigative approach consisting of water and clay core sample analysis, including stable isotopes and specific degraders, as well as analysis for chlorinated solvents, degradation products, donor fermentation products and redox-sensitive parameters combined with modelling has been applied. The results showed that the chlorinated solvent TCE was converted into its daughter products (cDCE, VC and ethene) but complete conversion of contaminants to ethene (as expected) was not achieved within a timeframe of 4 years. Large variation in the effect of ERD in the clay matrix between sites, boreholes and even between cores was observed. Four years post ERD initiation,

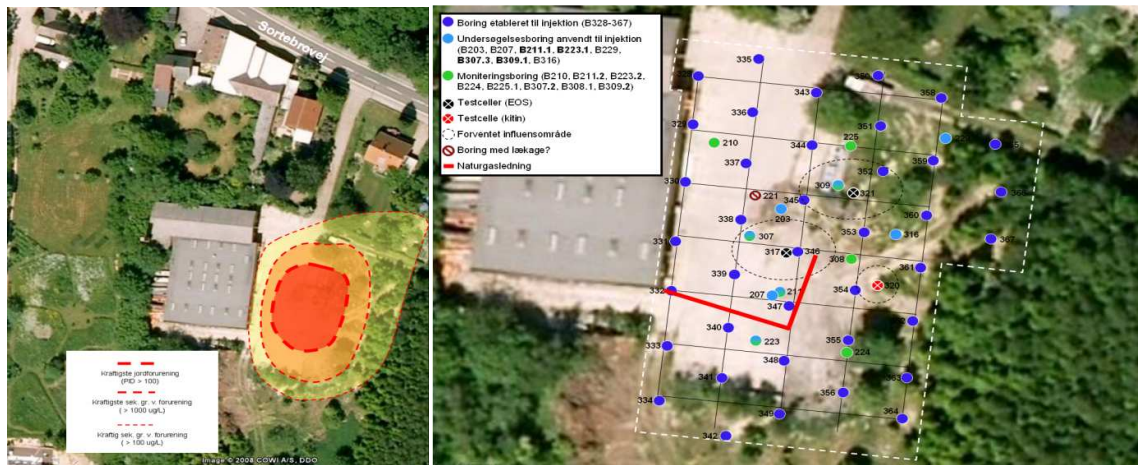
FIGURE 1. Sortebrovej site. TCE-contamination and network of injection wells for substrate and bioaugmentation culture injection in clay till.

The TCE contamination is located 10-20 m bgs. in a basal clay till deposit with imbedded sand stringers (mm thick). An emulsified oil substrate (EOS) and a bioaugmentation culture (KB1®) with specific degraders *Dhc* were injected in a network of wells screened at 2 depth intervals (10-13 and 15-18 m bgs.). The locations of TCE-contamination and injection wells are illustrated in Figure 1. The substrate and culture spread in the natural sand stringers embedded in the clay till. Further site and remediation description is given in Manoli et al. (2012).

Clay till cores were collected from the treated areas at Sortebrovej after 2 and 4 years after initiation of ERD. At Gl. Kongevej cores were collected after 4 years. The location of cored boreholes at the sites is shown in Figures 1 (Sortebrovej) and 2 (Gl. Kongevej). Very detailed subsampling (on 0.25-5 cm scale) of the intact clay cores for matrix profile analysis was performed. Only the 4-year data is presented in this paper. Analysis for chlorinated solvents, degradation products, donor fermentation products and redox-sensitive parameters in clay till samples were conducted as described earlier by Scheutz et al. (2010). Selected clay core subsamples from Sortebrovej were analysed for *Dhc* and *vcrA* by GEUS. For Gl. Kongevej, selected core subsamples were analysed for stable carbon isotopes by University of Neuchatel and selected core subsamples were analysed for *Dhc*, *Dhb*, *vcrA*, *bvcA*, and *vcrA* and *bvcA* activity by GEUS. These microbial analyses and stable isotope analyses are described in detail in Damgaard et al. (2012).

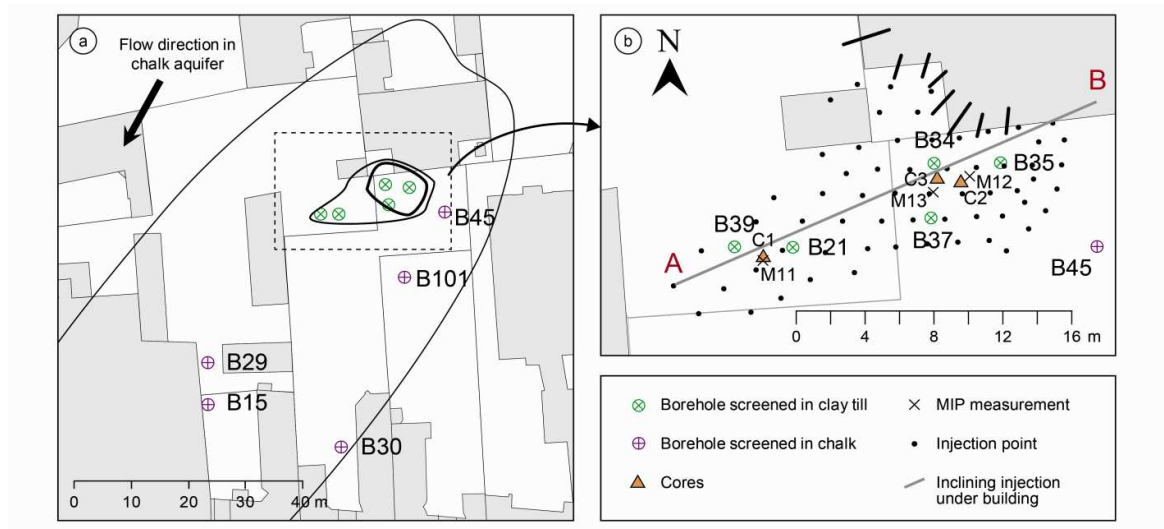
FIGURE 2. Gl. Kongevej site. TCE-contamination and network of injection points for substrate and bioaugmentation culture in source and plume areas in clay till. Modified from Damgaard et al. (2012).

The TCE-contamination is found in a fractured basal clay till unit 2-8 m bgs. A source zone and a downgradient plume area, outlined in Figure 2, were treated. The TCE concentration level is very high in the source zone suggesting the occurrence of dense non-aqueous phase liquid TCE at the site. Organic molasses donor and Bioclear Dechlorinating bioaugmentation cul-ture with specific degraders *Dhc* were injected with a drive-point probe (Geoprobe) in 25-cm-spaced vertical intervals over the depth inter-val 2-7 m bgs. in the clay till in a closely spaced network. The injection method was tested in a clay till by Christiansen et al. (2012) and found suitable for enhanced reactant injections in clay till for in-situ treatment compared to other enhanced injection methods (pneumatic and hydraulic fracturing) by Christiansen et al. (2010). Further site and remediation description is given in Damgaard (2012) and Damgaard et al. (2012). The underlying chalk aquifer is affected by the contamination (also outlined in Figure 2) and remediation. For further information on the effects on the primary aquifer, see Damgaard et al. (2012) and Chambon et al. (2010).

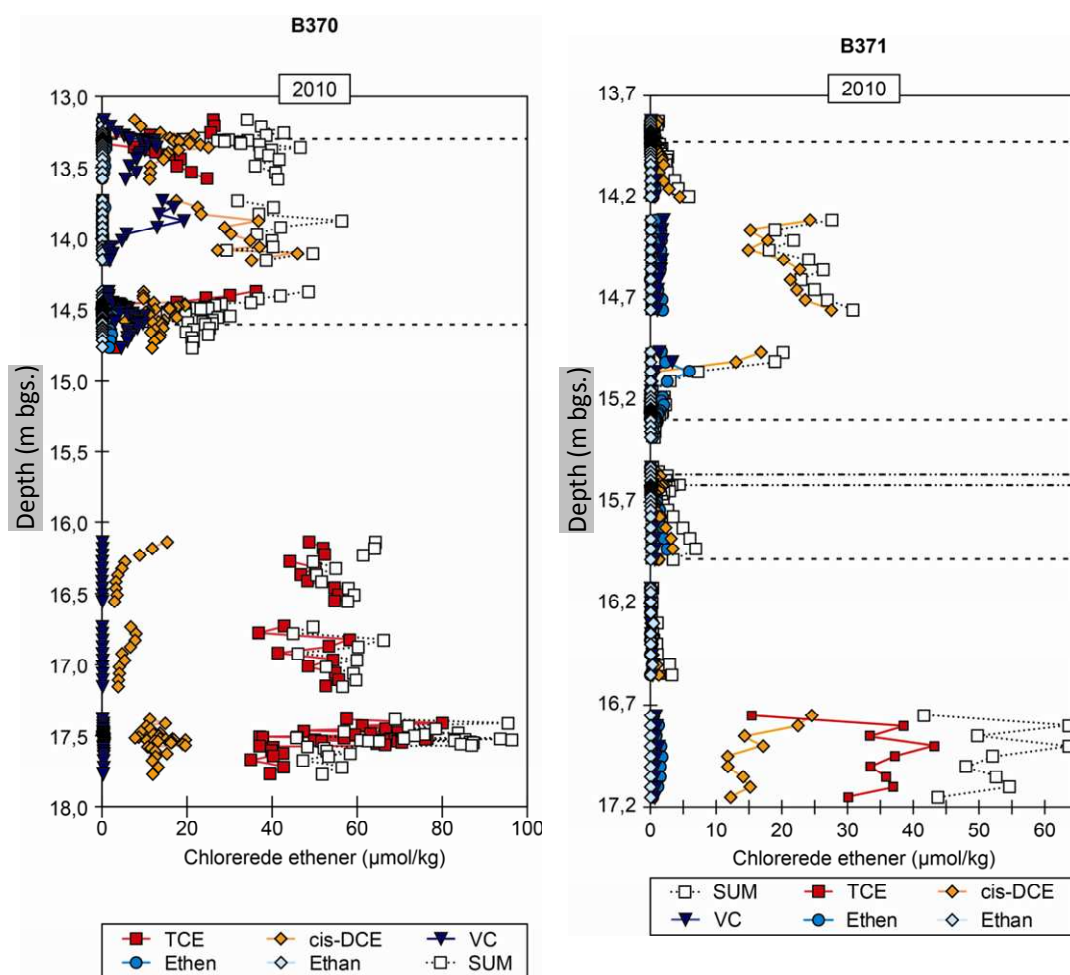
FIGURE 3. Sortebrovej Site. Detailed concentration profiles for TCE and degradation products in clay till for 2 cored boreholes representing different ERD developments.

Large variation was likewise observed in the development of ERD in the clay till matrix. Profiles of TCE and degradation products for cored boreholes representing an area where DoD in groundwater leveled off at about 50% (B370) and an area where DoD reached >95% (B371, located ~20 m from B370) are illustrated in Figure 3. No difference in clay till type or texture for the 2 locations was recorded. In the upper part of B370, relatively narrow zones with TCE degradation to cis-DCE and VC with little apparent ethene production are observed mostly in relation to imbedded sand stringers. Microbial analysis confirmed the presence of *Dhc* and *vcrA* in the narrow zone with TCE degradation in the matrix surrounding a sand stringer. In the deeper part of the clay till, no significant dechlorination appears to be taking place. This is likely a result of inadequate substrate injection and distribution.

In B371 much more significant degradation is occurring. Practically complete degradation is seen in some parts and degradation to cis-DCE with minor further dechlorination

is seen in other parts. The total concentration level appears to have decreased significantly and even where complete dechlorination appears to have taken place, the ethene and ethane concentrations are low. This indicates loss or further degradation of ethene and ethane. It is also noteworthy that VC concentrations are low compared to cis-DCE and ethene, suggesting cis-DCE to be the time-limiting step in the sequential dechlorination.

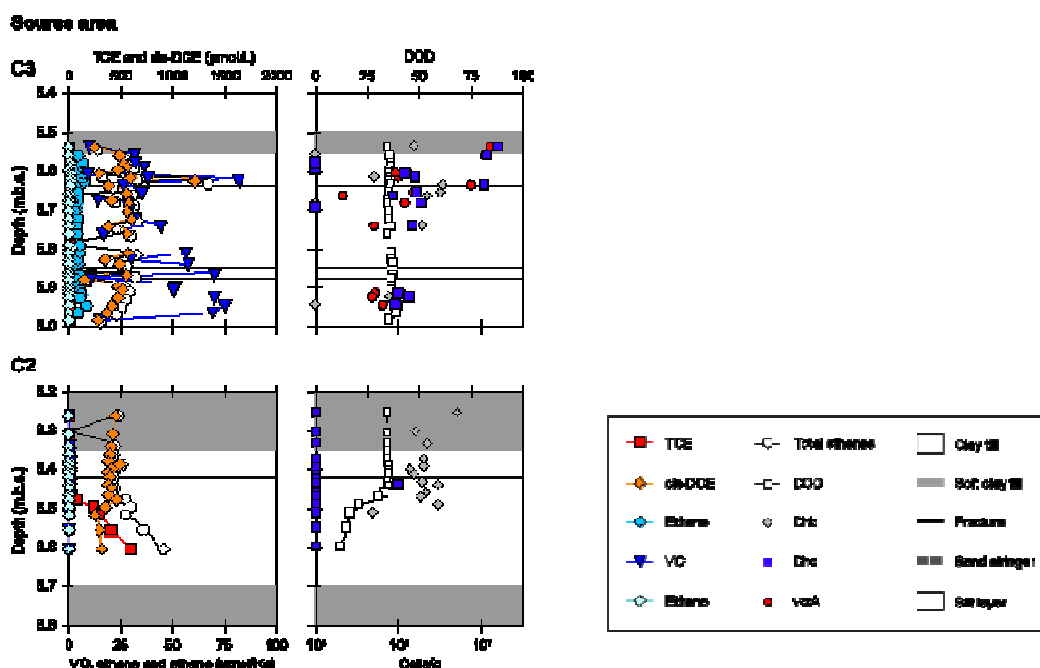
FIGURE 4. G1. Kongevej site. Example core sections from the source zone illustrating sequential dechlorination and microbial composition. Modified from Damgaard (2012).

The analysis of core subsamples from the source zone revealed a 1.8 m long zone where TCE had been degraded to cis-DCE in the up-per part of the clay till (in C3). In part of this zone, further degradation to VC and ethene had started to take place, see Figure 4 core C3. In this part of the zone, microbial analysis revealed high numbers of *Dhc* and *vcrA* and less frequently *Dhb*.

In the deeper and much firmer clay till, the analysis revealed narrow zones with degradation of TCE to cis-DCE, but without significant further dechlorination to VC and ethane. One such narrow zone is illustrated in Figure 4 core C2. In this zone only single samples near fractures had a measurable content of *Dhc*, whereas *Dhb* were abundant. Hence, it appears that *Dhb* rather than *Dhc* were responsible for TCE-degradation to cis-DCE. Stable carbon isotope analysis suggested that kinetic desorption of TCE is limiting the further sequential dechlorination of cis-DCE. This, in turn, suggests that the dynamic change in microbial population composition (from *Dhb* to *Dhc* with *vcrA*) in the matrix may be controlled by kinetic TCE desorption.
